**AIRCRAFT
ACCIDENT
REPORT**
Trans World Airlines Flight 800
Part I
Consideration of Reasonable Probable Causes

**Report on the accident to
Trans World Airlines Flight 800
Boeing 747-131, N93119
Near East Moriches, New York
July 17, 1996
by John Barry Smith,
Independent Aircraft Accident Investigator**

Part I: Consideration of Reasonable Probable Causes

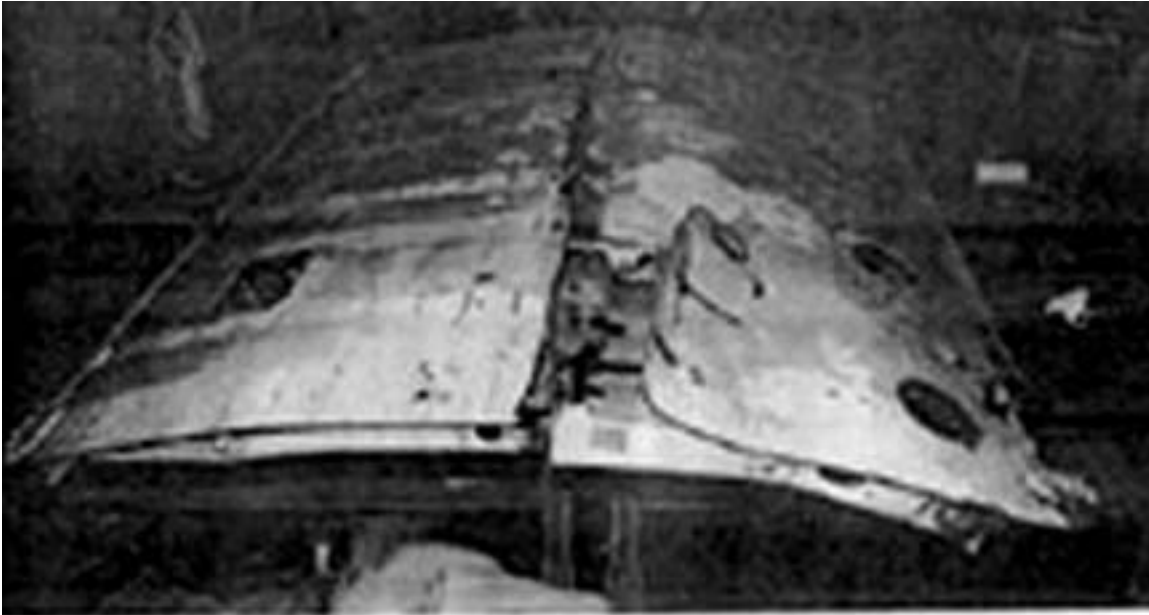
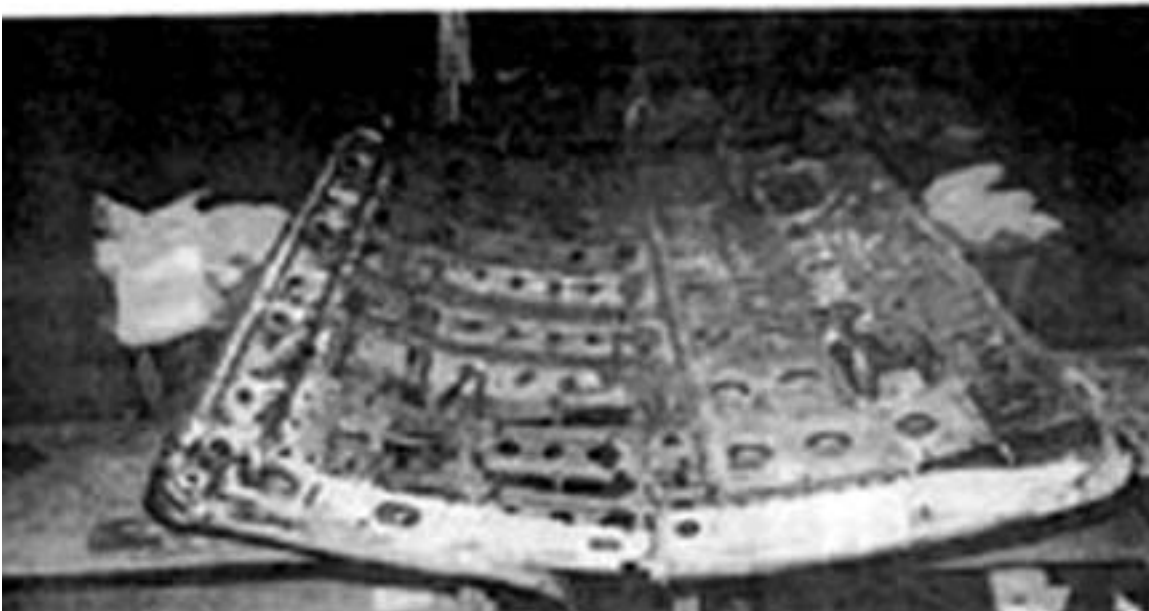
United Airlines Flight 811 forward cargo door showing missing aft pressure relief door and jammed open status of forward pressure relief door according to NTSB AAR 92/02.

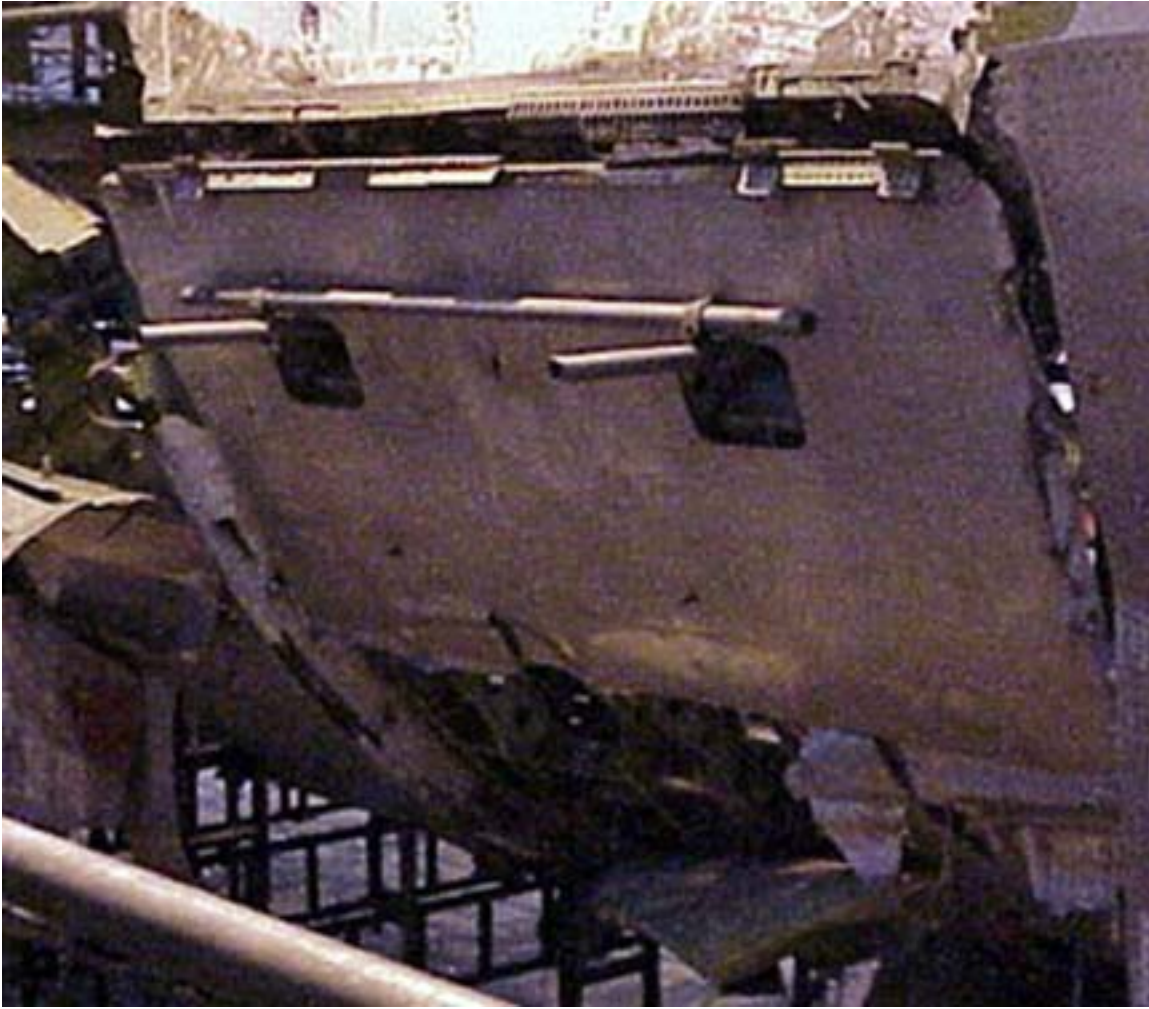
Pan Am Flight 103 Forward cargo door showing missing aft and forward pressure relief doors.

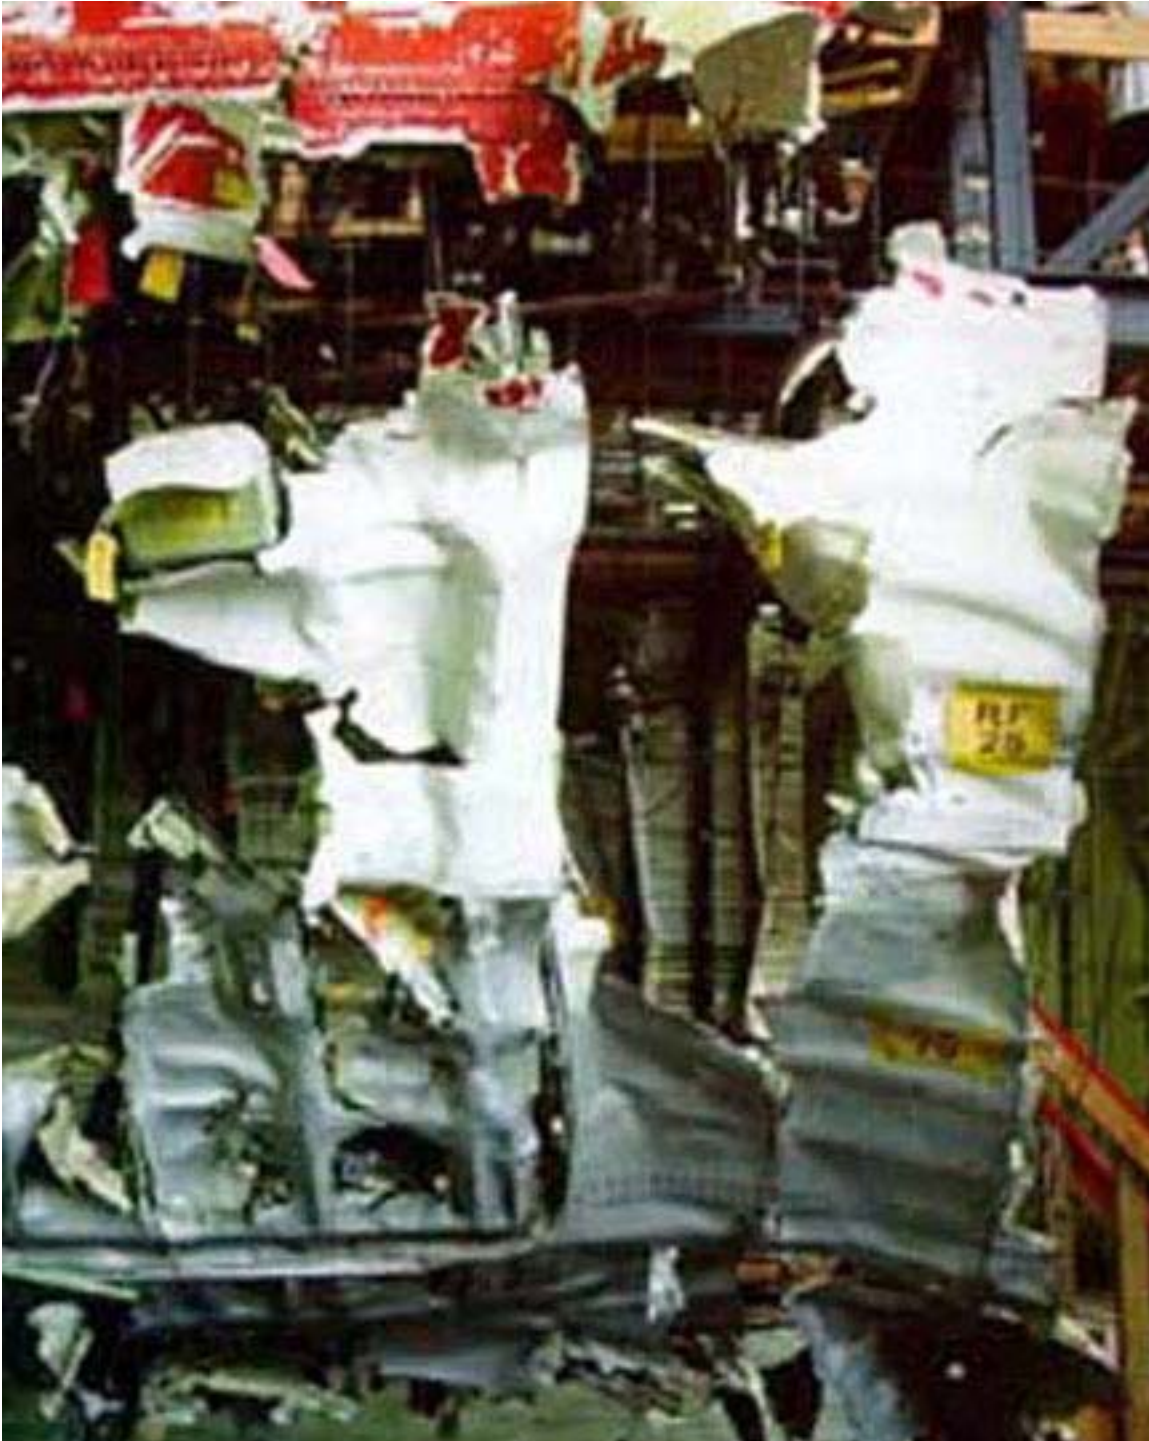
Trans World Airlines Flight 800 Forward cargo door showing separated and replaced forward pressure relief door.

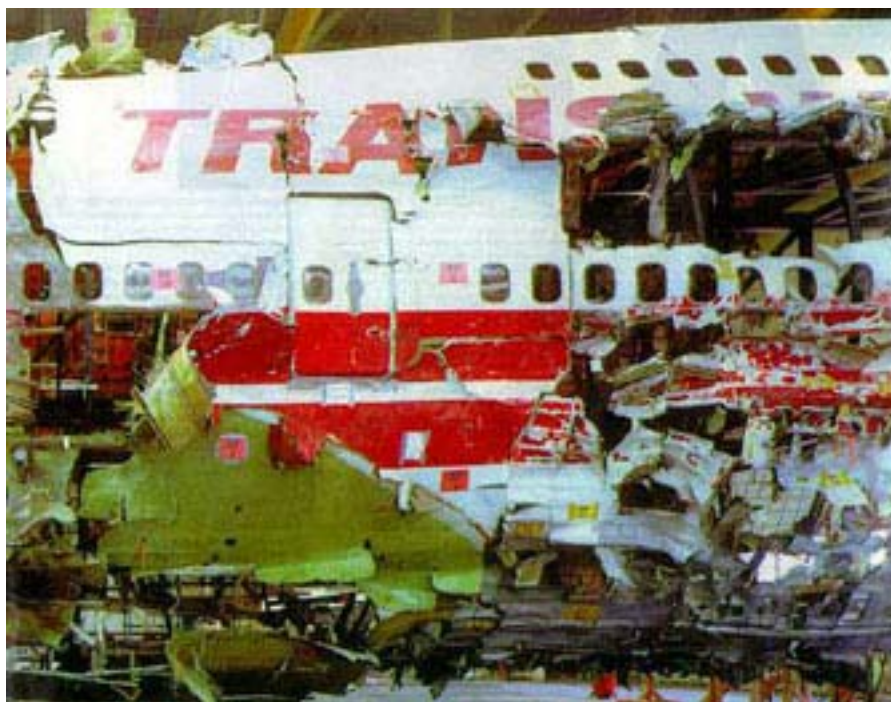
Above is a NTSB photograph of the wreckage reconstruction of Trans World Airlines Flight 800 starboard side over and forward of the wing. Fuselage station 600 is to the right extending to fuselage station 960 to the left in the photograph. A little over half of the forward cargo door is the shattered area in the lower right hand section. An outward opening petal shaped rupture can be seen at the aft midspan latch of the forward cargo door. The mildly damaged right hand, number two passenger door is in the middle left of the photograph.

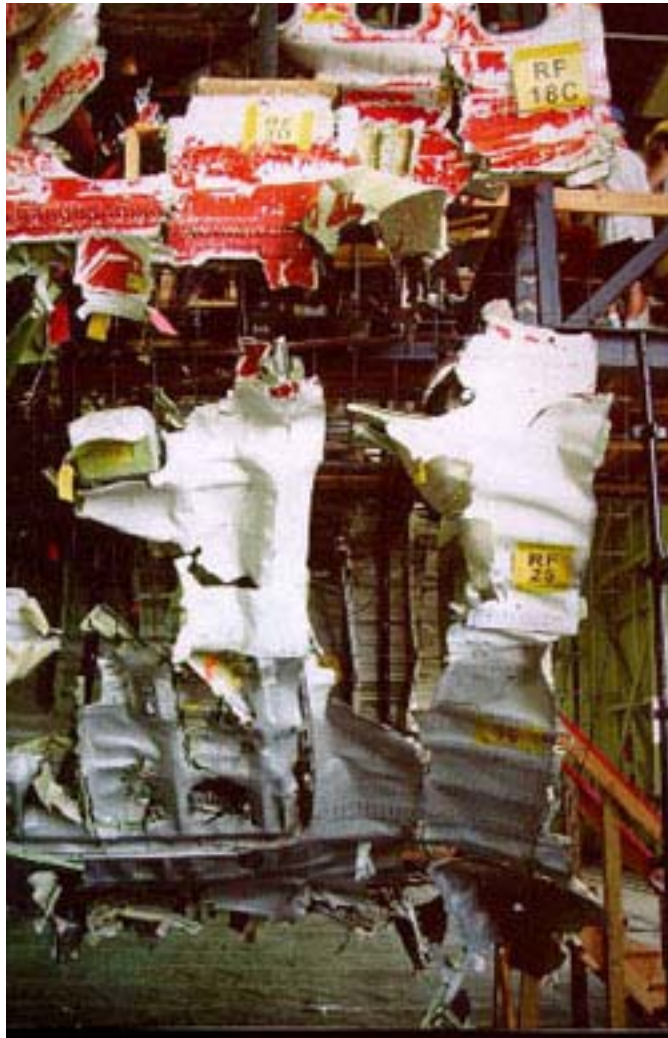
Above is a closeup photograph of about a half of the Trans World Airlines Flight 800 forward cargo door extending from fuselage station 520 on the right to fuselage station 620 to the left in the photograph. The cargo door hinge is in red near the top of the photograph. The outward opening petal shaped oval rupture is located at the forward midspan latch of the forward cargo door.

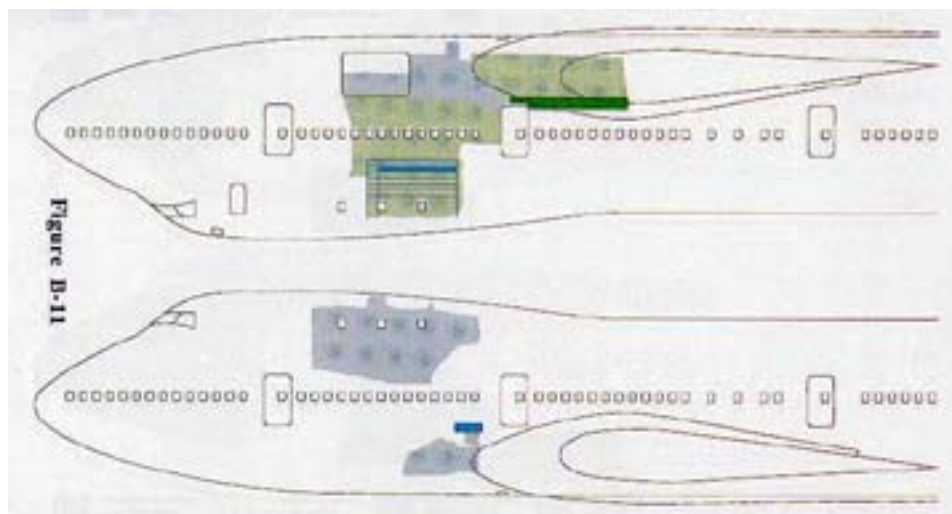
Above drawing from Figure B-11 of the AAIB report shows the large amounts of fuselage skin around the forward cargo door (top drawing) torn away at initial event time while on the port side (bottom drawing) at the same time, only a few pieces are torn off. The dark blue rectangle is the very small 'bomb explosion' shatter zone which is purported to have caused the aircraft to break in two.

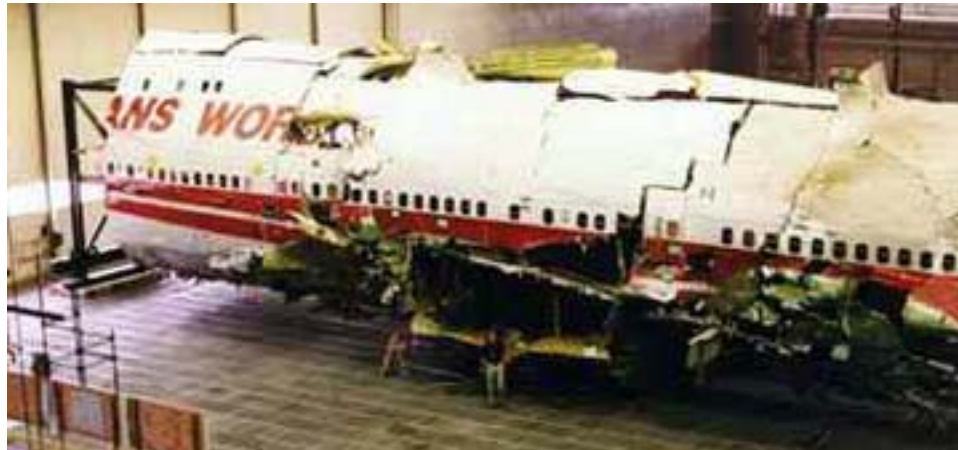
Above photograph shows the smooth port side forward of the wing (nose to left in photograph), while directly opposite the starboard side is shattered and torn. There was no inflight damage to engines Nos. 1 or 2, both on the port side of the aircraft.
